Manhole Inspection Summary

Manhole # S23Q__003MH

Insp Date: **4/4/08 1:42 PM**

Location Address: **1701 WASHINGTON BLVD.**

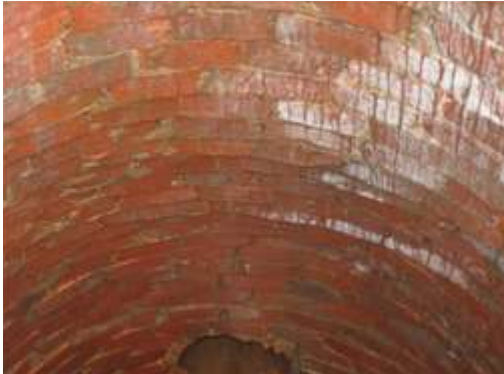
Defect 1

Infiltration: ☐ None ☐ Joint ☐ Cracks ☐ Mortar ☐ Roots ☒ **Wall**

EVIDENCE OF BARREL INFILTRATION

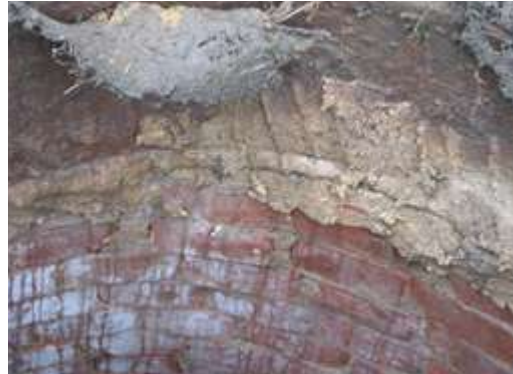
Defect 2

Condition: ☐ Sound ☒ **Cracked** ☐ Root Intrusion ☐ Loose Brick ☐ Deteriorated

Infiltration: ☐ None ☒ **Joint** ☐ Cracks ☒ **Mortar** ☐ Roots ☐ Wall

MISSING MORTAR WITH EVIDENCE
OF CHIMNEY INFILTRATION

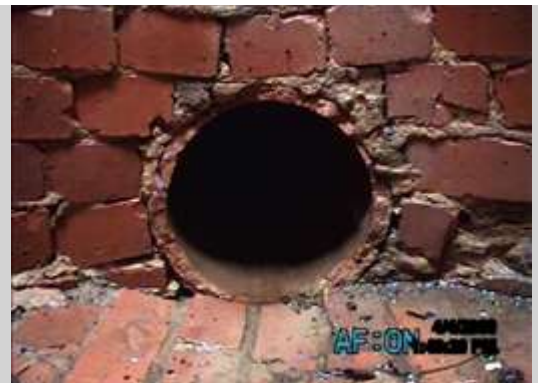
12 O'Clock Outflow

8 in. Circular Gravity Sewer
Pipe Out @ 12 O'Clock

Infiltration: **None** Pipe Seal Cond: **Sound**
